TECHNICAL REPORT M-245

June 1978

Foam Material Applications in Theater of Operations Construction

DAMAGED BUILDING REPAIR WITH POLYURETHANE FOAM

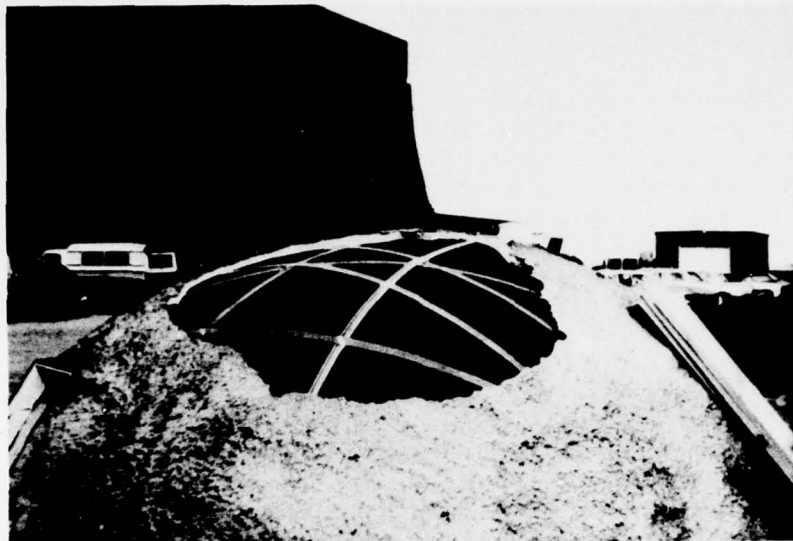
**Figure 1.** Hole in dome structure. Wood lath strips attached to give required shape.

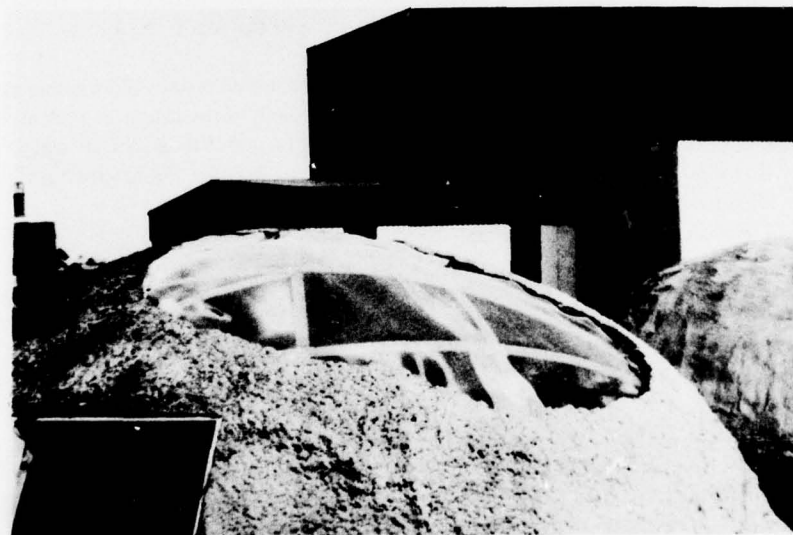
**Figure 2.** Aluminum screen wire in place.

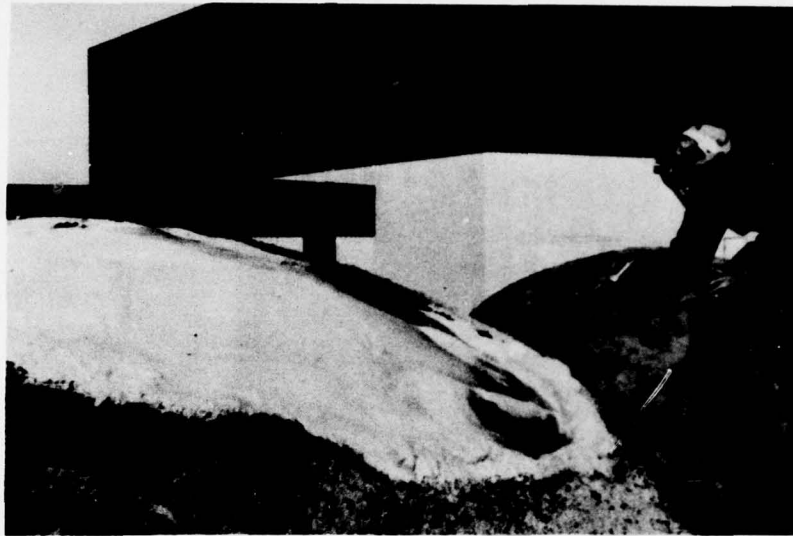
**Figure 3.** Foam spray application on screen wire to form patch.

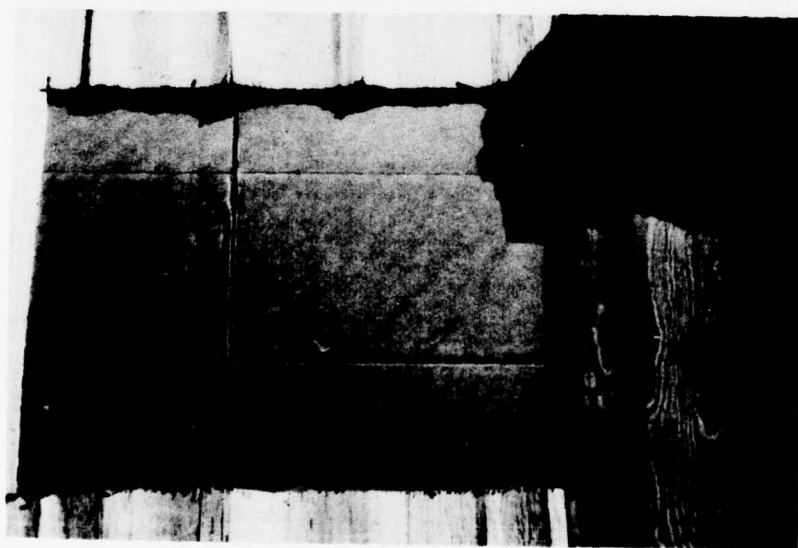
Figures 5 through 8 show holes prepared for repair using insect screen, corrugated paper box, plywood and burlap, respectively, as substrate. Figure 9 shows all four holes ready for repair work to begin.

Figure 6. Prepared hole with corrugated cardboard substrate.

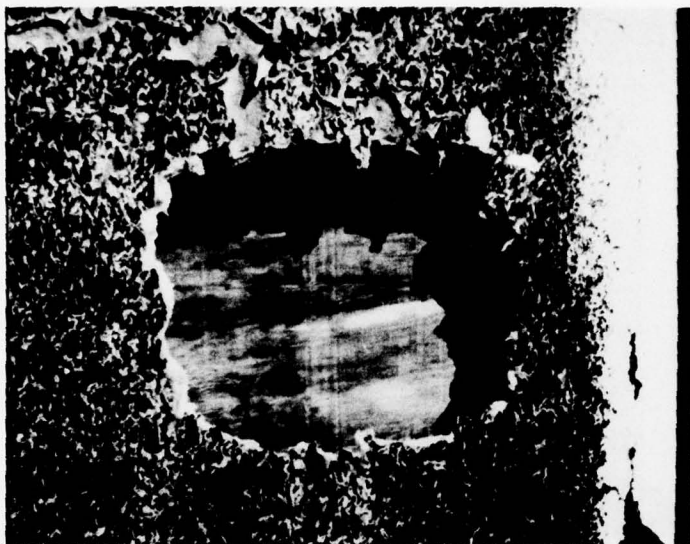
Figure 7. Prepared hole with plywood substrate.

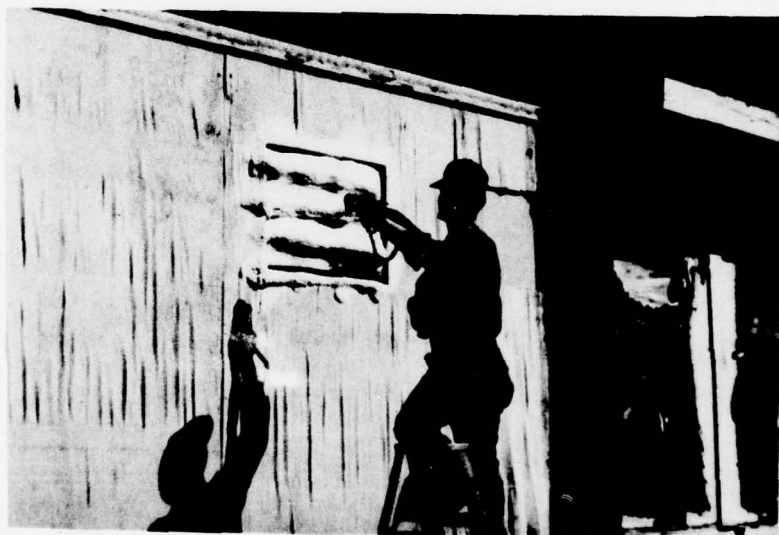
**Figure 10.** Spray foam being applied to insect screen substrate to make patch.

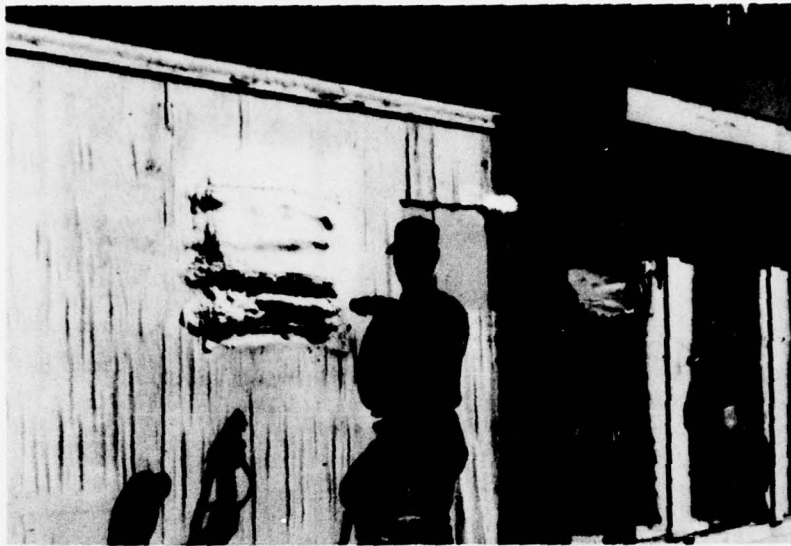
**Figure 11.** An excess of foam may be applied and trimmed off, if desired.

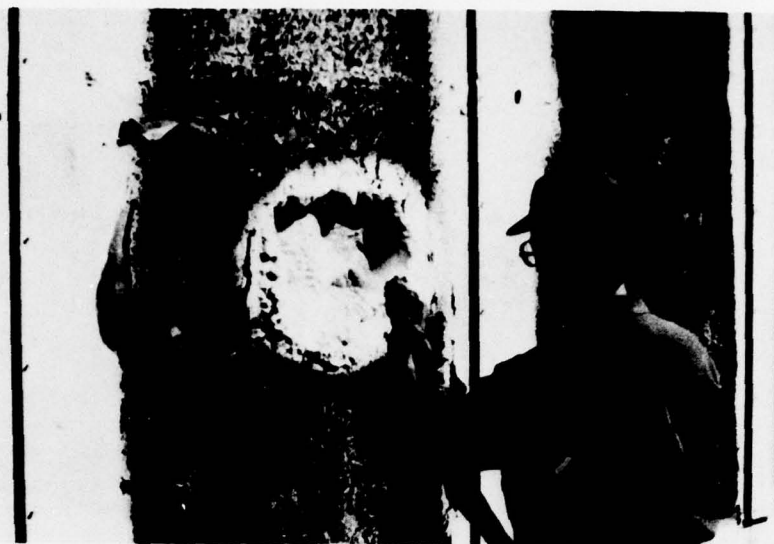
**Figure 13.** Filling in the remainder of the repair patch with foam.

The best repair procedure is first to apply foam around the edges of the hole in order to provide a good seal to the existing wall (Figure 12). The remainder of the patch can then be filled in from the edges, as shown in Figure 13. Figure 14 shows completion of the foaming.

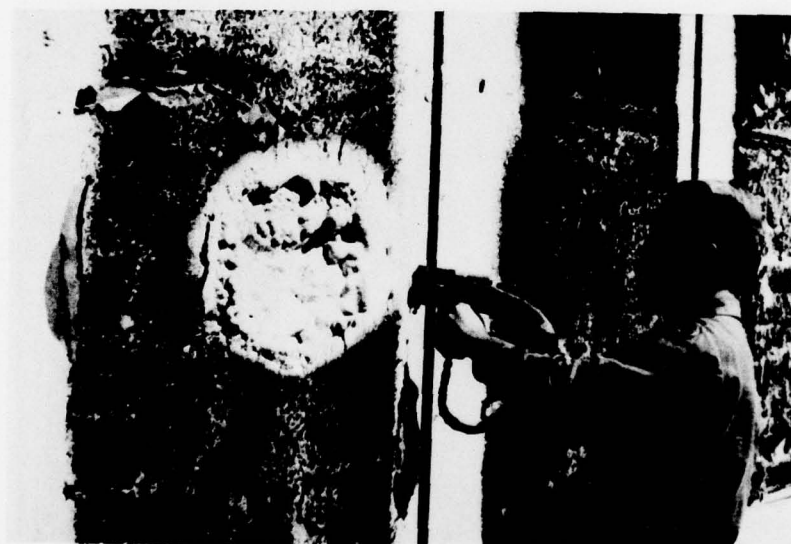
**Figure 14.** Completing the patch.

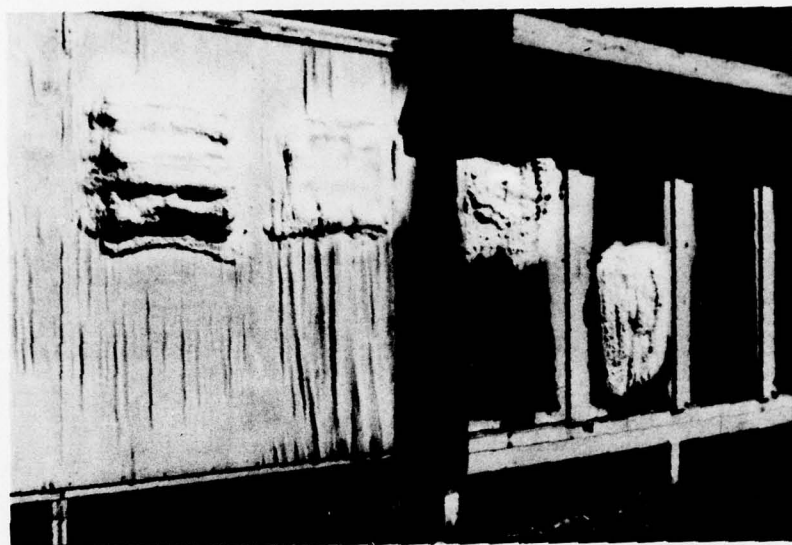
Figure 15. The four holes completely repaired.

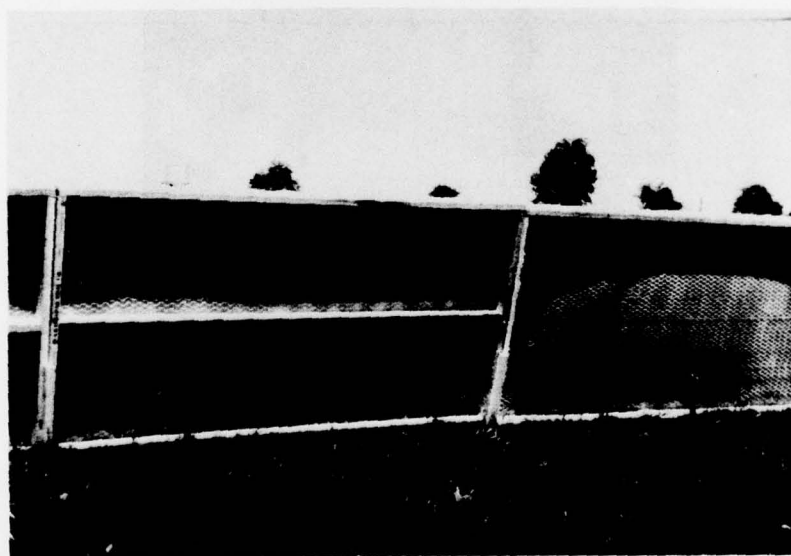
Figure 16. One large frame with an intermediate stud and one without.

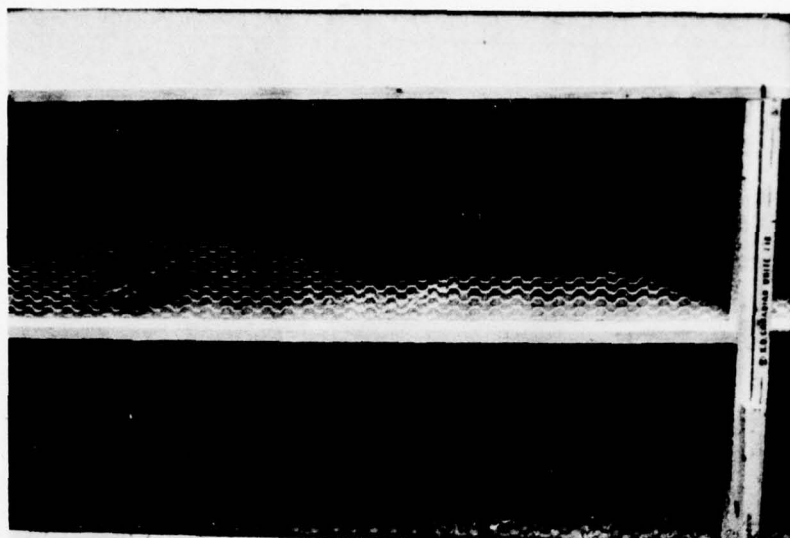
**Figure 17.** Rear view of large frame with intermediate stud, showing more detail of hexagonal netting substrate.

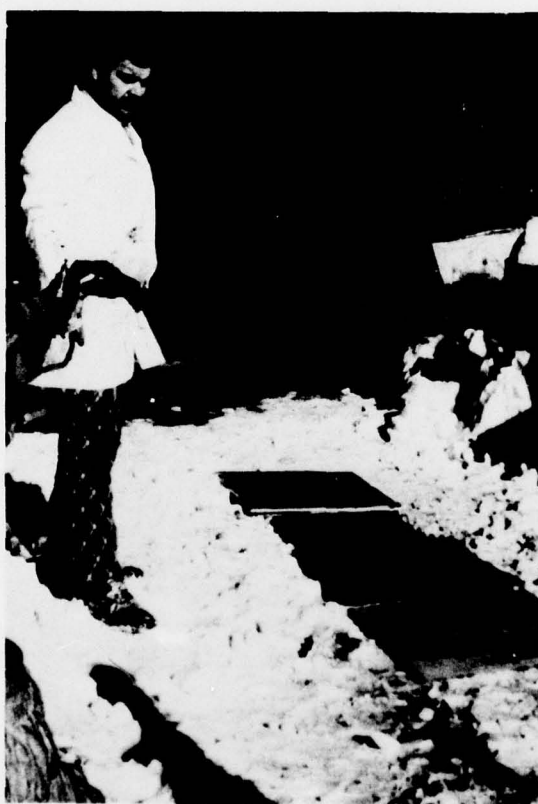
The four substrate materials (plywood, corrugated paper, aluminum sheet, and gypsum wall board) were left outside overnight at ambient temperature ( $-10^{\circ}\text{F}$  [ $-23^{\circ}\text{C}$ ]) (Figure 18). As shown in Figure 19, foaming occurred more slowly on the materials that provide the greatest heat sink effect. However, after the initial delay, foaming occurs much as it does under more favorable conditions (Figure 20). There is a slight increase in the density of the foam and it takes about twice as long to react. Otherwise the foam is essentially normal. If foam build-up is too rapid, the foaming action tends to pull the unreacted surface layer away from the surface, resulting in poor bonding.

**Figure 18.** Four substrate materials (plywood, corrugated paper, aluminum sheet, and gypsum board, from front to rear) conditioned and ready for foam spray.
